Characterisation of hydrogen and strain interactions in the microstructure of duplex stainless steel using x-ray diffraction

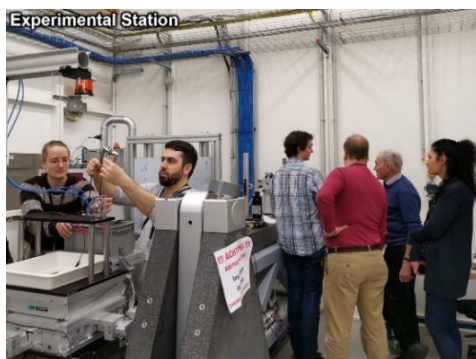
The investigation of the early stages of hydrogen-induced material degradation on commercial duplex stainless steel was carried out with high energy XRD with low angles for surface characterization as well as layer by layer for effects of hydrogen ingress and strains through the material.

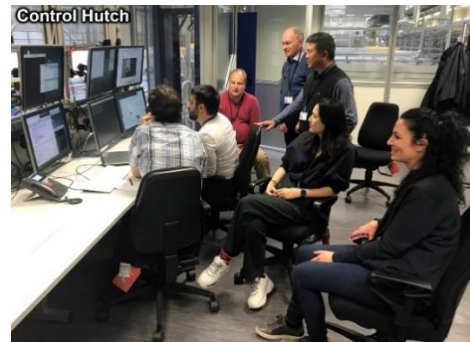
This was done under in operando conditions. The Swedish beamline P21.2 at the German synchrotron Petra III (DESY) in Hamburg was used. The conditions were strained material in sodium chloride with a cathodic protection potential imposed. The work was performed by the partners and beamline scientists at DESY (Dr Timo Müller and Dr Ulrich Lienert) present.
