Failure Modes in Pavements

Flexible Pavement Distress Modes

Sigurdur Erlingsson

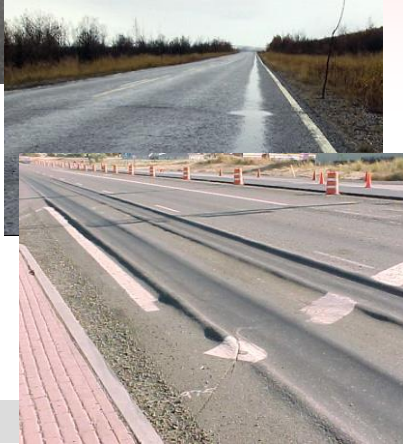
Rutting

- **Description:** Surface depression in the wheel path. Pavement uplift (shearing) may occur along the sides of the rut. Ruts are particularly evident after a rain when they are filled with water.

- **Possible Causes:** Permanent deformation in any of a pavement's layers or subgrade usually caused by consolidation or lateral movement of the materials due to traffic loading. Specific causes of rutting can be:

- Insufficient compaction of pavement layers during construction.
 - Compression of unbound layers (base course, subbase)
 - Subgrade rutting (e.g., as a result of inadequate pavement structure)

- Improper mix design or manufacture (e.g., excessively high asphalt content, excessive mineral filler, insufficient amount of angular aggregate particles)

- **Repair:** A heavily rutted pavement should be investigated to determine the root cause of failure (e.g. insufficient compaction, subgrade rutting, poor mix design or studded tyre wear). Slight ruts (< 8 mm deep) can generally be left untreated. Pavement with deeper ruts should be levelled and overlaid.

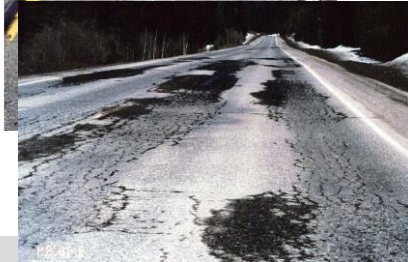
Fatigue Cracking

- **Description:** Series of interconnected cracks caused by fatigue failure of the HMA surface (or stabilized base) under repeated traffic loading. In thin pavements, cracking initiates at the bottom of the HMA layer where the tensile stress is the highest then propagates to the surface as one or more longitudinal cracks. This is commonly referred to as "bottom-up" or "classical" fatigue cracking. In thick pavements, the cracks most likely initiate from the top in areas of high localized tensile stresses resulting from tire-pavement interaction and asphalt binder aging (top down cracking). After repeated loading, the longitudinal cracks connect forming many-sided sharp-angled pieces that develop into a pattern resembling the back of an alligator or crocodile.

- **Problem:** Indicator of structural failure, cracks allow moisture infiltration, roughness, may further deteriorate to a pothole.
- **Possible Causes:** Inadequate structural support, which can be caused by a number of things. A few of the more common ones are listed here:

- Loss of base, subbase or subgrade support (e.g., poor drainage or spring thaw resulting in a less stiff base).
 - Stripping on the bottom of the HMA layer (the stripped portion contributes little to pavement strength so the effective HMA thickness decreases)

- Increase in loading (e.g., more or heavier loads than anticipated in design)
 - Inadequate structural design
 - Poor construction (e.g., inadequate compaction)

- **Repair:** A fatigue cracked pavement should be investigated to determine the root cause of failure. Any investigation should involve digging a pit or coring the pavement to determine the pavement's structural makeup as well as determining whether or not subsurface moisture is a contributing factor. Once the characteristic alligator pattern is apparent, repair by crack sealing is generally ineffective. Fatigue crack repair generally falls into one of two categories:

- *Small, localized fatigue cracking indicative of a loss of subgrade support.* Remove the cracked pavement area then dig out and replace the area of poor subgrade and improve the drainage of that area if necessary. Patch over the repaired subgrade.

- *Large fatigue cracked areas indicative of general structural failure.* Place an HMA overlay over the entire pavement surface. This overlay must be strong enough structurally to carry the anticipated loading because the underlying fatigue cracked pavement most likely contributes little or no strength.

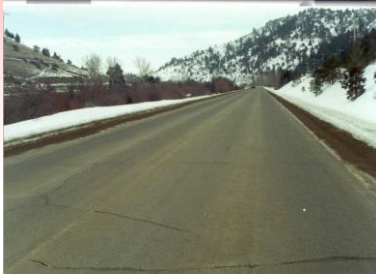
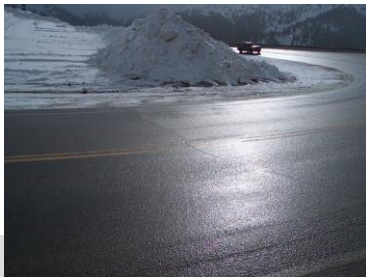
Transversal (thermal) cracking

- **Description:** Cracks perpendicular to the pavement's centreline or lay-down direction. Usually a type of thermal cracking.
- **Problem:** Allows moisture infiltration, roughness.
- **Possible Causes:** Several including:
 - Shrinkage of the HMA surface due to low temperatures or asphalt binder hardening.
 - Reflective crack caused by cracks beneath the surface HMA layer.
 - Top-down cracking.
- **Repair:** Strategies depend upon the severity and extent of the cracking:
 - *Low severity cracks (< 12 mm wide and infrequent cracks).* Crack seal to prevent (1) entry of moisture into the pavement through the cracks and (2) further ravelling of the crack edges.
 - *High severity cracks (> 12 mm wide and numerous cracks).* Remove and replace the cracked pavement layer with an overlay.

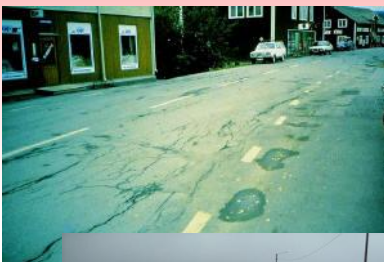
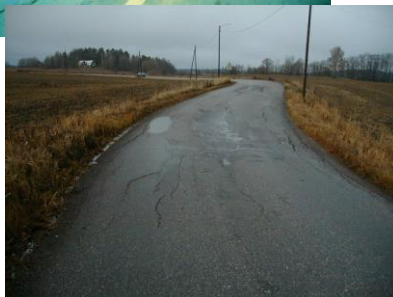
Frost heave/thaw (action) cracking

- Frost action can be quite detrimental to pavements and refers to two separate but related processes:
 - Frost heave. An upward movement of the subgrade resulting from the expansion of accumulated soil moisture as it freezes.
 - Thaw weakening. A weakened subgrade condition resulting from soil saturation as ice within the soil melts.
- This problem occurs primarily in soils containing fine particles (often termed "frost susceptible" soils), while clean sands and gravels (small amounts of fine particles) are non-frost susceptible (NFS). Thus, the degree of frost susceptibility is mainly a function of the percentage of fine particles within the soil.

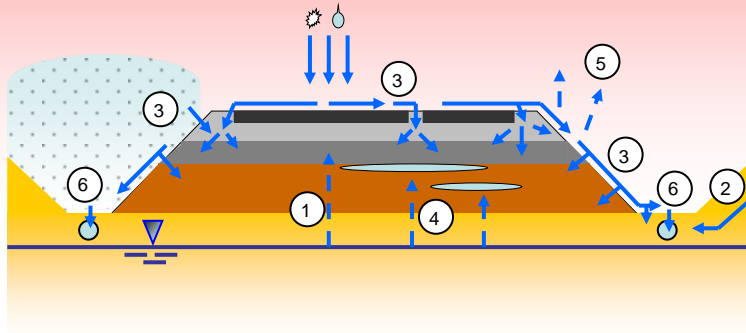
Frost heave/thaw (action) – cont.

Water intake

- ① Capillary rise
- ② Lateral transfer of moisture
- ③ Infiltration from precipitation
- ④ Frost action - capillarity

Moisture extraction

- ⑤ Evaporation
- ⑥ Drainage

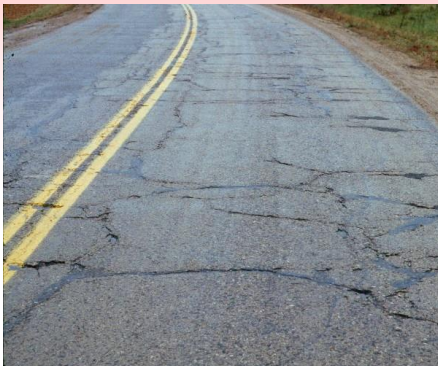
- **Description:** Interconnected cracks that divide the pavement up into rectangular pieces. Blocks range in size from approximately 0.1 m² to 9 m². Block cracking normally occurs over a large portion of pavement area.

- **Problem:** Roughness, Allows moisture infiltration.
- **Possible Causes:** HMA shrinkage and daily temperature cycling. Typically caused by an inability of asphalt binder to expand and contract with temperature cycles because of asphalt binder aging.

- Poor choice of asphalt binder in the mix design
- **Repair:** Strategies depend upon the severity and extent of the block cracking:
 - *Low severity cracks (< 12 mm wide).* Crack seal to prevent (1) entry of moisture into the structure through the cracks and (2) further raveling of the crack edges. HMA can provide years of satisfactory service after developing small cracks if they are kept sealed.

- *High severity cracks (> 12 mm wide and cracks with ravelled edges).* Remove and replace the cracked pavement layer with an overlay.

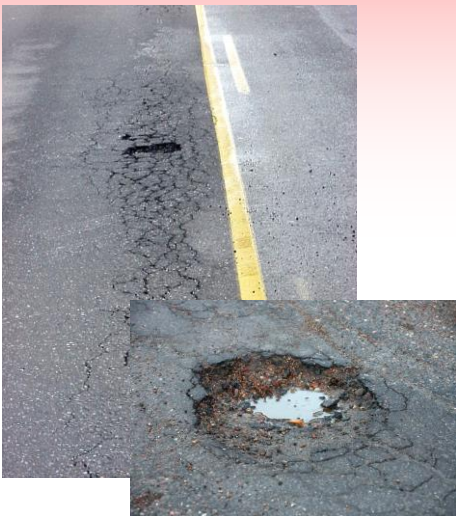
- **Description:** Small, bowl-shaped depressions in the pavement surface that penetrate all the way through the HMA layer down to the base course. They generally have sharp edges and vertical sides near the top of the hole. Potholes are most likely to occur on roads with thin HMA surfaces (25 to 50 mm) and seldom occur on roads with 100 mm or deeper HMA surfaces.
- **Problem:** Roughness (serious vehicular damage can result from driving across potholes at higher speeds), moisture infiltration.
- **Possible Causes:** Generally, potholes are the end result of alligator cracking. As alligator cracking becomes severe, the interconnected cracks create small chunks of pavement, which can be dislodged as vehicles drive over them. The remaining hole after the pavement chunk is dislodged is called a pothole.
- **Repair:** Patching.

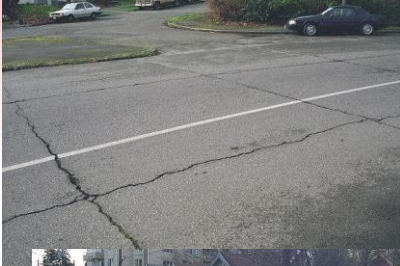
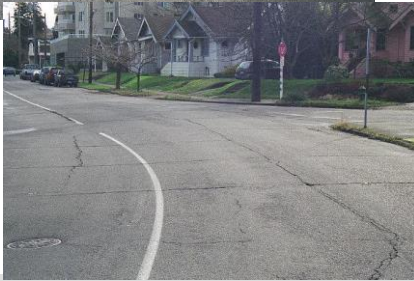
Joint Reflection Cracking

- **Description:** Cracks in a flexible overlay of a rigid pavement. The cracks occur directly over the underlying rigid pavement joints. Joint reflection cracking does not include reflection cracks that occur away from an underlying joint or from any other type of base (e.g., cement or lime stabilized).

- **Problem:** Allows moisture infiltration, roughness.
- **Possible Causes:** Movement of the PCC slab beneath the HMA surface because of thermal and moisture changes. Generally not load initiated, however loading can hasten deterioration.

- **Repair:** Strategies depend upon the severity and extent of the cracking:
 - *Low severity cracks (< 12 mm wide and infrequent cracks).* Crack seal to prevent (1) entry of moisture into the pavement structure through the cracks and (2) further ravelling of the crack edges.

- *High severity cracks (> 12 mm wide and numerous cracks).* Remove and replace the cracked pavement layer with an overlay.

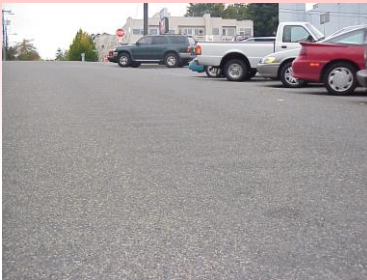
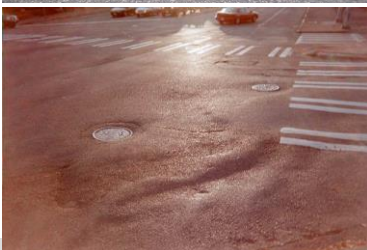
Corrugation and shoving

- **Description:** A form of plastic movement typified by ripples (corrugation) or an abrupt wave (shoving) across the pavement surface. The distortion is perpendicular to the traffic direction. Usually occurs at points where traffic starts and stops (corrugation) or areas where HMA abuts a rigid object (shoving).

- **Problem:** Roughness
- **Possible Causes:** Usually caused by traffic action (starting and stopping) combined with:
 - An unstable (i.e. low stiffness) HMA layer (caused by mix contamination, poor mix design, poor HMA manufacturing, or lack of aeration of liquid asphalt emulsions)

- Excessive moisture in the pavement structure
- **Repair:** A heavily corrugated or shoved pavement should be investigated to determine the root cause of failure. Repair strategies generally fall into one of two categories:

- *Small, localized areas of corrugation or shoving.* Remove the distorted pavement and patch.
 - *Large corrugated or shoved areas indicative of general HMA failure.* Remove the damaged pavement and overlay.

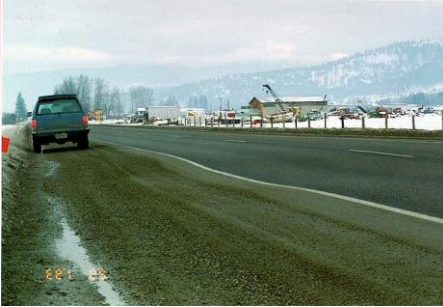
- **Description:** Localized pavement surface areas with slightly lower elevations than the surrounding pavement. Depressions are very noticeable after a rain when they fill with water.
- **Problem:** Roughness, depressions filled with substantial water can cause vehicle hydroplaning.
- **Possible Causes:** Irregular frost heave or subgrade settlement resulting from inadequate compaction during construction or poor quality (soft) subgrade.
- **Repair:** By definition, depressions are small localized areas. A pavement depression should be investigated to determine the root cause of failure (i.e., subgrade settlement or frost heave). Depressions should be repaired by removing the affected pavement then digging out and replacing the area of poor subgrade. Patch over the repaired subgrade.

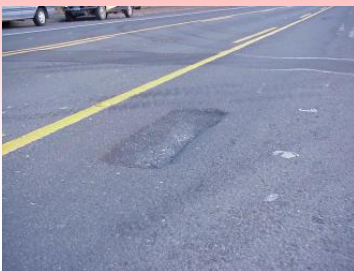
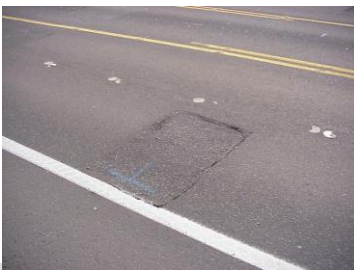
Patching

- **Description:** An area of pavement that has been replaced with new material to repair the existing pavement. A patch is considered a defect no matter how well it performs.
- **Problem:** Roughness.
- **Possible Causes:** Previous localized pavement deterioration that has been removed and patched.
- **Repair:** Patches are themselves a repair action. The only way they can be removed from a pavement's surface is by new either overlay.

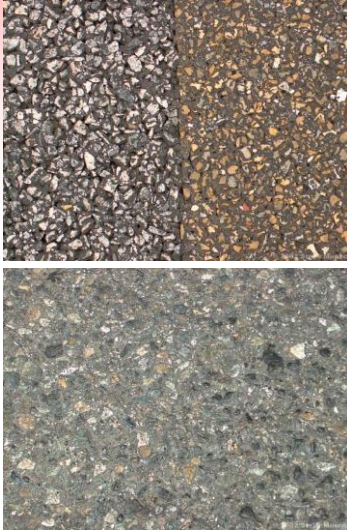
Polishing (polished aggregates)

- **Description:** Areas of HMA pavement where the portion of aggregate extending above the asphalt binder is either very small or there are no rough or angular aggregate particles.
- **Problem:** Decreased skid resistance.
- **Possible Causes:** Repeated traffic applications. Generally, as a pavement ages the protruding rough, angular particles become polished. This can occur quicker if the aggregate is susceptible to abrasion or subject to excessive studded tyre wear.
- **Repair:** Apply a skid-resistant slurry seal or BST or overlay.

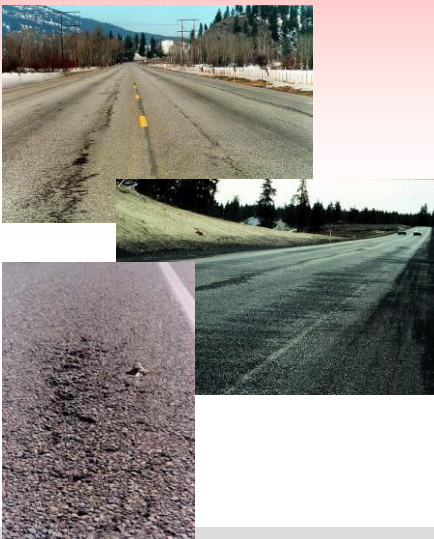
Ravelling

- **Description:** The progressive disintegration of an HMA layer from the surface downward as a result of the dislodgement of aggregate particles.
- **Problem:** Loose debris on the pavement, roughness, water collecting in the ravelled locations resulting in vehicle hydroplaning, loss of skid resistance.

- **Possible Causes:** Several including:
 - Loss of bond between aggregate particles and the asphalt binder as a result of:
 - A dust coating on the aggregate particles that forces the asphalt binder to bond with the dust rather than the aggregate

- Aggregate Segregation. If fine particles are missing from the aggregate matrix, then the asphalt binder is only able to bind the remaining coarse particles at their relatively few contact points.

- Inadequate compaction during construction. High density is required to develop sufficient cohesion within the HMA (paving in cold weather).
 - Mechanical dislodging by certain types of traffic (studded tyres, snowplow blades or tracked vehicles).

- **Repair:** A ravelled pavement should be investigated to determine the root cause of failure. Repair strategies generally fall into one of two categories:

- *Small, localized areas of raveling.* Remove the ravelled pavement and patch.
 - *Large ravelled areas indicative of general HMA failure.* Remove the damaged pavement and overlay.

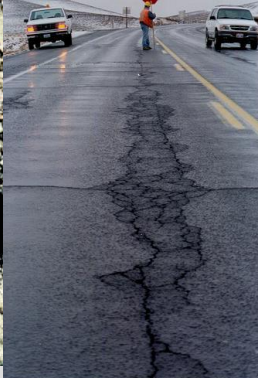
Stripping

- **Description:** The loss of bond between aggregates and asphalt binder that typically begins at the bottom of the HMA layer and progresses upward. When stripping begins at the surface and progresses downward it is usually called ravelling. The third photo show the surface effects of underlying stripping.

- **Problem:** Decreased structural support, rutting, shoving/corrugation, ravelling, or cracking (alligator and longitudinal).

Possible Causes: Bottom-up stripping is very difficult to recognize because it manifests itself on the pavement surface as other forms of distress including rutting, shoving/corrugations, ravelling, or cracking. Typically, a core must be taken to positively identify stripping as a pavement distress.

- Poor aggregate surface chemistry.
- Water in the HMA causing moisture damage

Repair: A stripped pavement should be investigated to determine the root cause of failure (i.e., how did the moisture get in?). Generally, the stripped pavement needs to be removed and replaced after correction of any subsurface drainage issues.

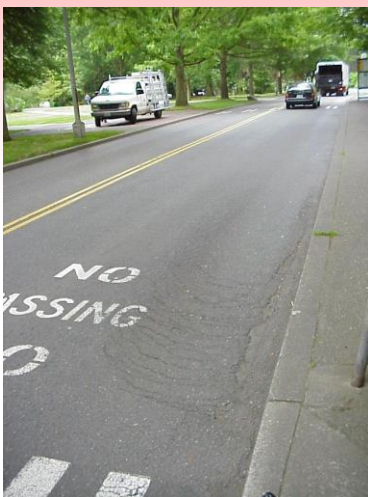
Slippage cracking

- **Description:** Crescent or half-moon shaped cracks generally having two ends pointed into the direction of traffic.

- **Problem:** Roughness, allows moisture infiltration.

- **Possible Causes:** Braking or turning wheels cause the pavement surface to slide and deform. The resulting sliding and deformation is caused by a low-strength surface mix or poor bonding between the surface HMA layer and the next underlying layer in the pavement structure.

- **Repair:** Removal and replacement of affected area.

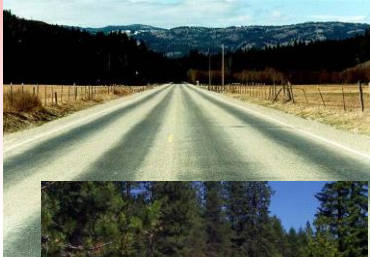
- **Description:** A film of asphalt binder on the pavement surface. It usually creates a shiny, glass-like reflecting surface that can become quite sticky.

- **Problem:** Loss of skid resistance skid (when wet).
- **Possible Causes:** Bleeding occurs when asphalt binder fills the aggregate voids during hot weather and then expands onto the pavement surface. Since bleeding is not reversible during cold weather, asphalt binder will accumulate on the pavement surface over time. This can be caused by one or a combination of the following:

- Excessive asphalt binder in the HMA (either due to mix design or manufacturing)
 - Excessive application of asphalt binder during BST application (as in the above figures)

- Low HMA air void content (e.g., not enough room for the asphalt to expand into during hot weather)
- **Repair:** The following repair measures may eliminate or reduce the asphalt binder film on the pavement's surface but may not correct the underlying problem that caused the bleeding:

- Minor bleeding can often be corrected by applying coarse sand to blot up the excess asphalt binder.
 - Major bleeding can be corrected by cutting off excess asphalt with a motor grader or removing it with a heater planer. If the resulting surface is excessively rough, resurfacing may be necessary.

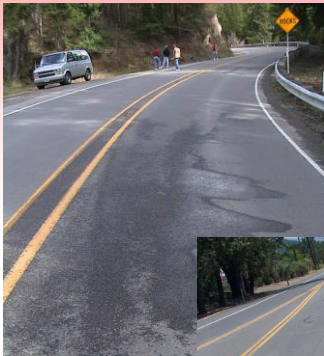
Water bleeding and Pumping

- **Description:** Water bleeding (left two photos) occurs when water seeps out of joints or cracks or through an excessively porous HMA layer. Pumping (right-most photo) occurs when water and fine material is ejected from underlying layers through cracks in the HMA layer under moving loads.

- **Problem:** Decreased skid resistance, an indication of high pavement porosity (water bleeding), decreased structural support (pumping)
- **Possible Causes:** Several including:

- Porous pavement as a result of inadequate compaction during construction or poor mix design
 - High water table
 - Poor drainage
- **Repair:** Water bleeding or pumping should be investigated to determine the root cause. If the problem is a high water table or poor drainage, pavement drainage should be improved. If the problem is a porous mix (in the case of water bleeding) a fog seal or slurry seal may be applied to limit water infiltration.
