Road Construction and Maintenance

-Road Profiles, Friction and Safety

johan.granlund@vectura.se, Chief Technology Officer

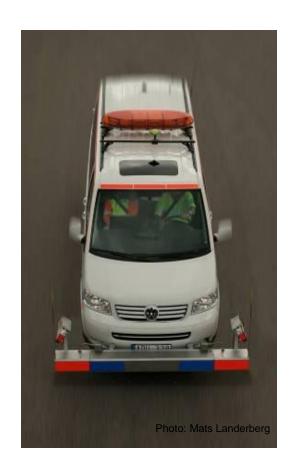
Movements of the rut bar.

Road condition surveying (Cont.)

Measurement at normal traffic speed:

- Travelled distance of the left nonpowered wheel.
- Distance to road surface is measured in 17 lateral positions, 16 000 times per second, about 1 sample/mm.

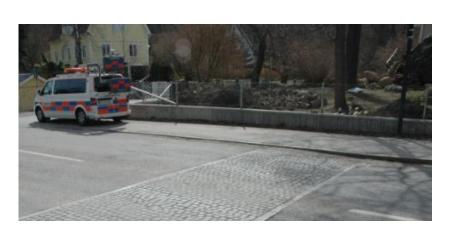
Road profiling with sweeping laser

Alignment, roughness and condition.

Laser/inertial technology.

Photos in full HD.

Retroreflection.

Height & Width Clearance.

Pavement and roadside are depicted in full 3D.

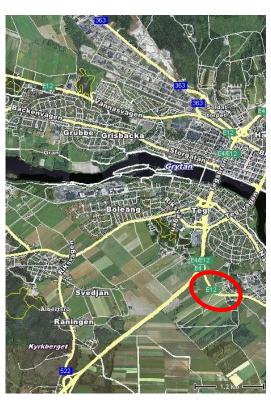
Analysis of the improperly banked "Curve of Death"

The improperly banked curve on road E12 have 5 crashes in 45 meter.

The need for side friction in the "Curve of Death" exceeds the friction supply value in the road design code VGU.

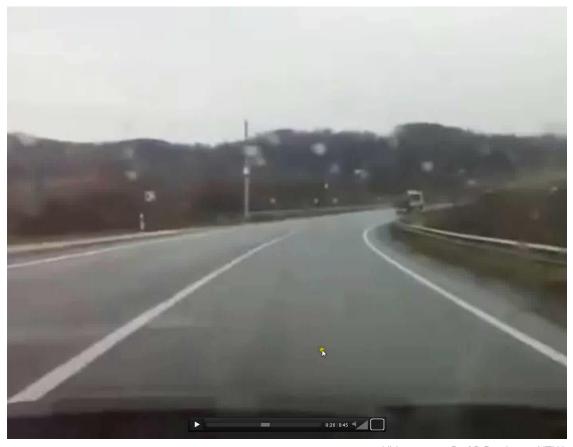
Hydroplaning at banked outer curve

Oncoming Heavy Goods Vehicle brakes at curve entrance. The waterfilm is very thick just there, due to improperly designed Drainage Gradient (DG).

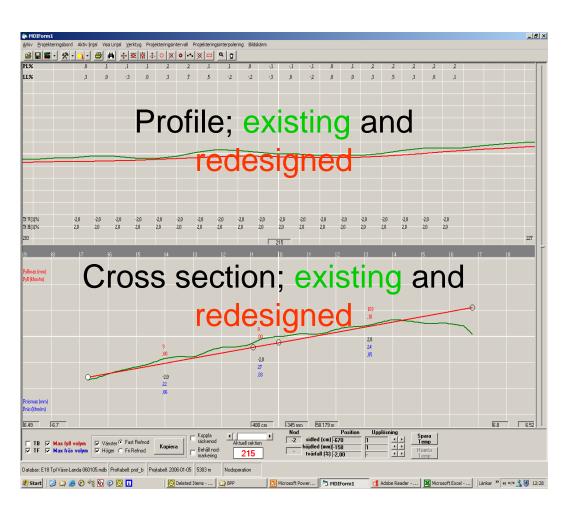
E18 Väse – Landa: Computer Aided Design (CAD) of **unevenness repair**.

Spot levelling and milling, followed by reinforcement by 60 mm bound base. On top: A thin wearing course with high resistance to wear from studded tyres.

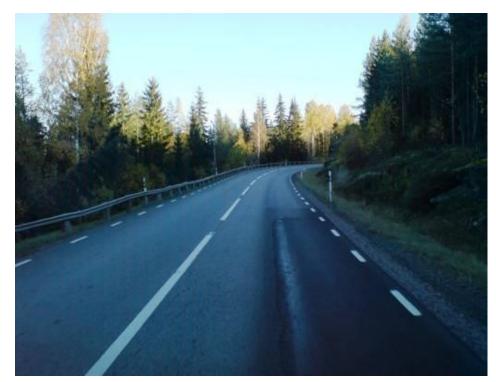
Entrance to sharp bend.

The edge has been patched with a "fat" asphalt mix.

NOTE: Sealed longitudinal joint.

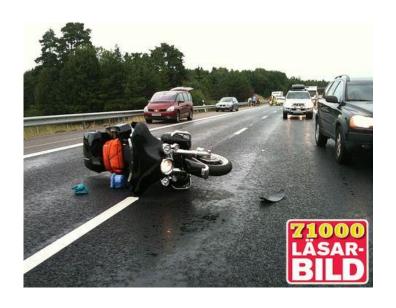
Low friction also cause reduced lateral stability

In-depth studies of fatal crashes show that the most frequent characteristic is that the vehicle has lost stability and skidded.

The friction between road and tyre limits forces in both longitudinal and lateral direction.

Forces acting to stabilize the vehicle in lateral direction, drops when braking. This may get critical in horizontal curves!
